TEST REPORT

IMR Report Number 200909987

Description
G4 Testing

Rope Slippage Test

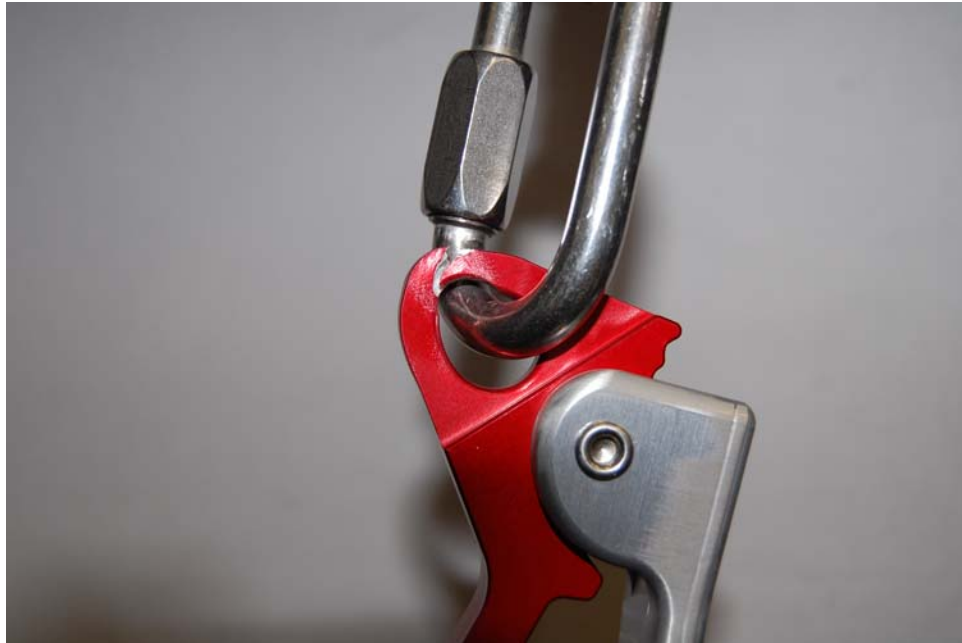
Figure 1: Typical failure mode

Sample	Load at Maximum Tensile Stress (lbf)	Failure Location
Red Handle #1	732	Rope Slipped
Silver Handle #1	671	Rope Slipped
Red Handle #1	4,500	Carabineer Hole Broke
Silver Handle #1	4,159	Carabineer Hole Broke
Red Handle #2	4,415	Carabineer Hole Broke
Silver Handle #2	4,484	Carabineer Hole Broke
